CASE STUDY

**water
treatment
services**

project: CHPP Corrosion Mitigation
product: WTS 5-0017
industry: Mining
location: Central Queensland

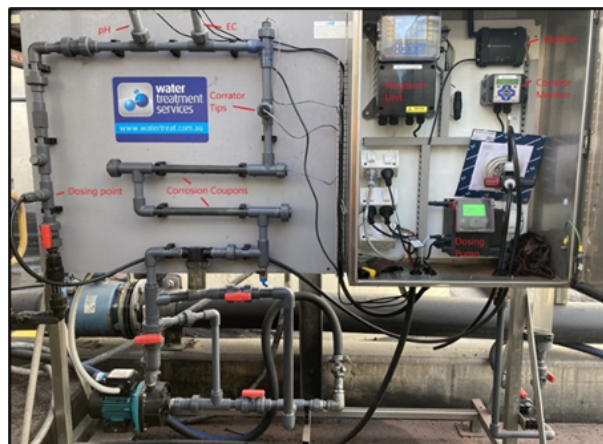
WTS 5-0017 onsite dosing skid with monitoring equipment

- Plug and play" dosing and monitoring skid
- Online monitoring of corrosion, pH, conductivity and ORP
- Dosing of WTS 5-0017 for corrosion mitigation
- 4 x corrosion coupon racks for monitoring at multiple points
- Pressure sustaining pump for carry-water
- Weekly online report
- Onsite service
- Offsite analysis of corrosion coupons

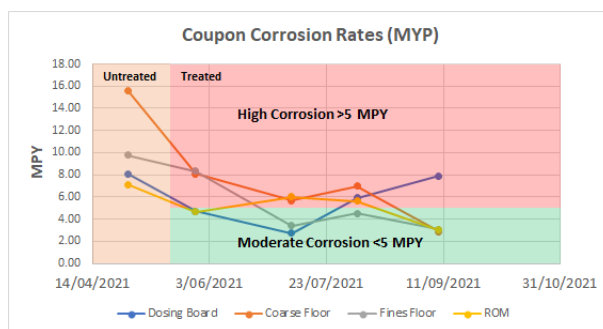
- 4 corrosion coupon monitoring locations:
 - Dosing board
 - Coarse floor
 - Fines floor
 - ROM
- Corrosion rates reduced at all locations
- Dosing rate at 1-2 ppm to achieve ~ 50% reduction in corrosion rate at 3 out of 4 locations
- Coarse floor corrosion reduced by ~ 80%

Corrosion decreased at all monitoring sites

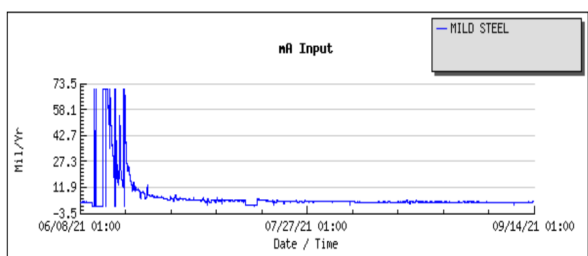
Online corrotor results; corrosion reduced by dosing WTS 5-0017

- Online corrotor/corrosion monitoring
- Untreated corrosion detected up to 70 MPY
- WTS 5-0017 achieves less than 5 MPY (~3MPY)

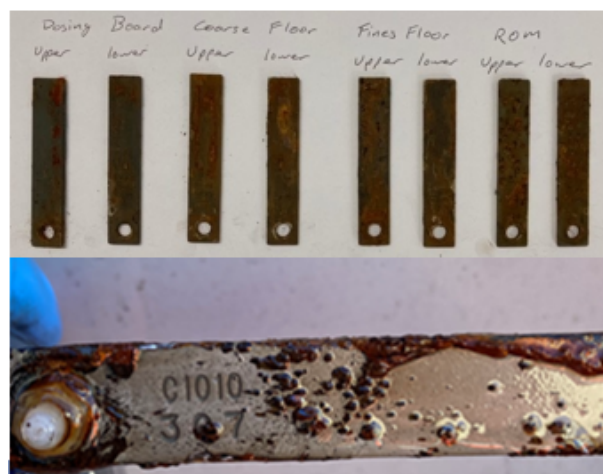
- Obvious visual corrosion on baseline corrosion coupons
- Corrosion observed occurring <5min after installation on untreated system
- Treated corrosion coupons visually showed less corrosion and more uncorroded base metal

Corrosion coupons: (TOP) untreated, (BOTTOM) treated
